# ENGINEERING REPORT

## EPG #105268

VILLAGE OF COXSACKIE  
NY0033545

## COLLECTION SYSTEM PLAN

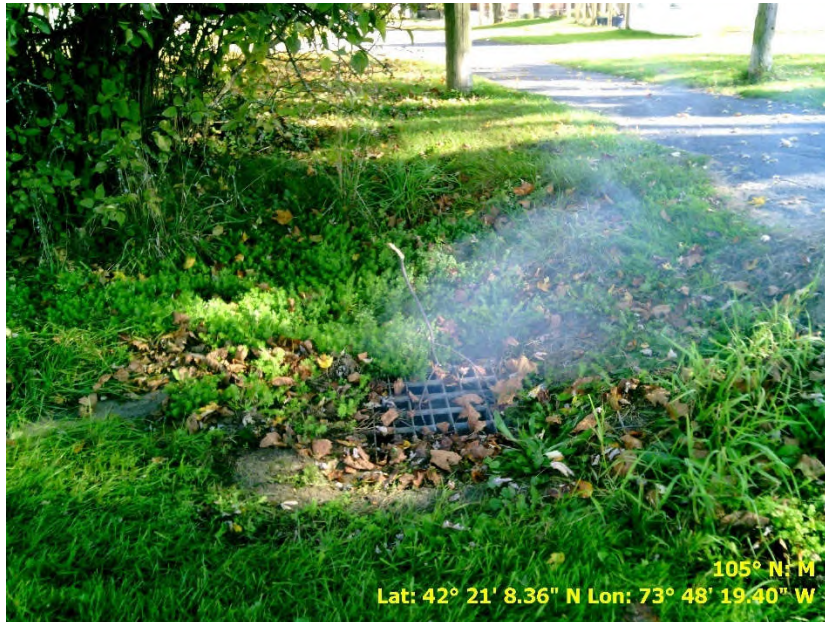
#### Catch Basins

Catch basins on the storm water system that allowed smoke to pass during testing indicate that the sewer collection pipe has a connection to the storm system. This could be direct connection, overflow pipes, and/or breaks in both systems allowing exchange.

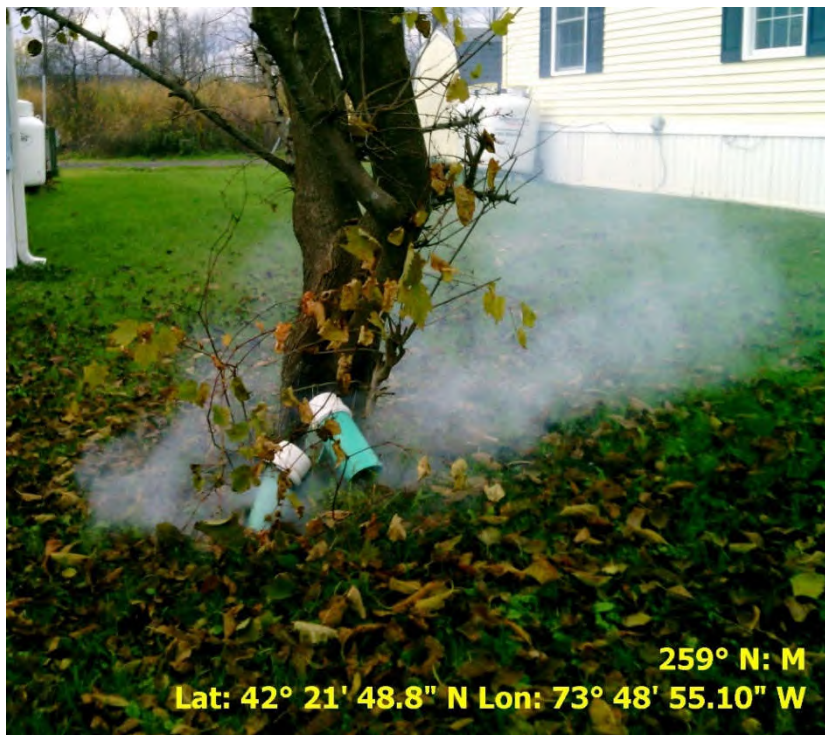
#### Clean Outs

Cleanouts with missing caps or other damage were found in low numbers in each area tested. Open cleanouts provide access for rain water to the sewer system.

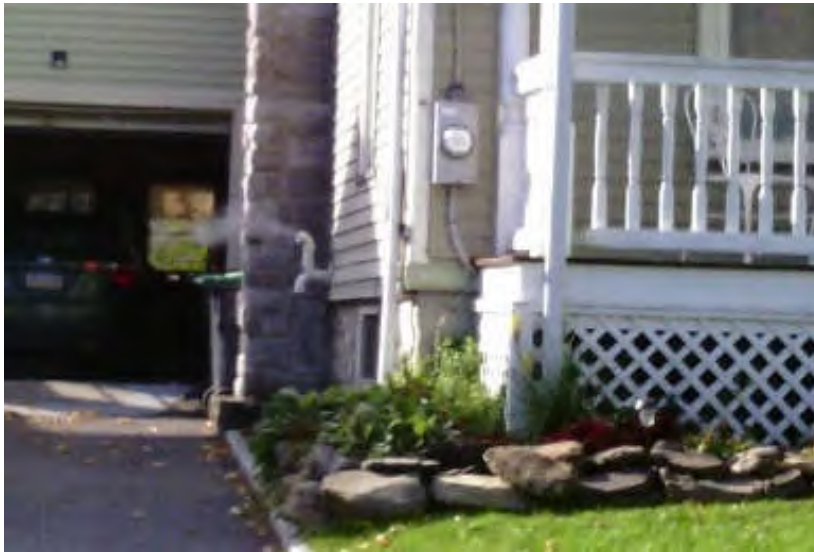
## Building Vents

Smoke from building basement vents indicates the basement sump or floor drains are connected to the sewer system.

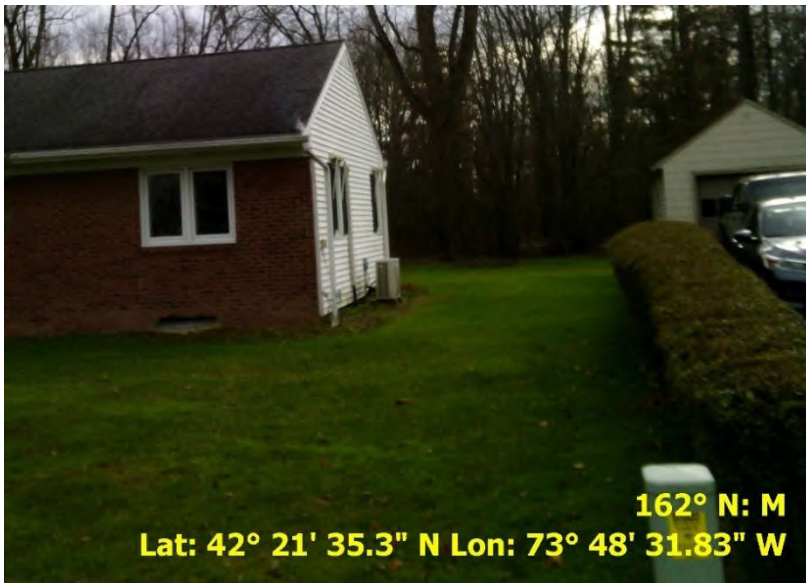
## Roof Leaders

Smoke from roof leaders on gutters indicates that this system is connected to the sewer system, instead of to stormwater.

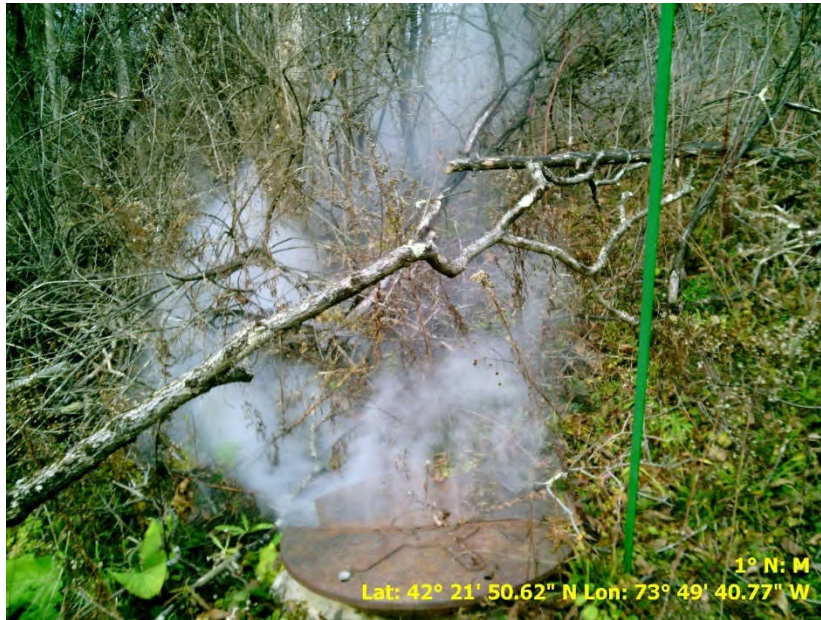
## Manholes

Excessive smoke from manholes or the ground nearby indicates leaking manholes that allow rain/stormwater into the sewer collection system during rain events

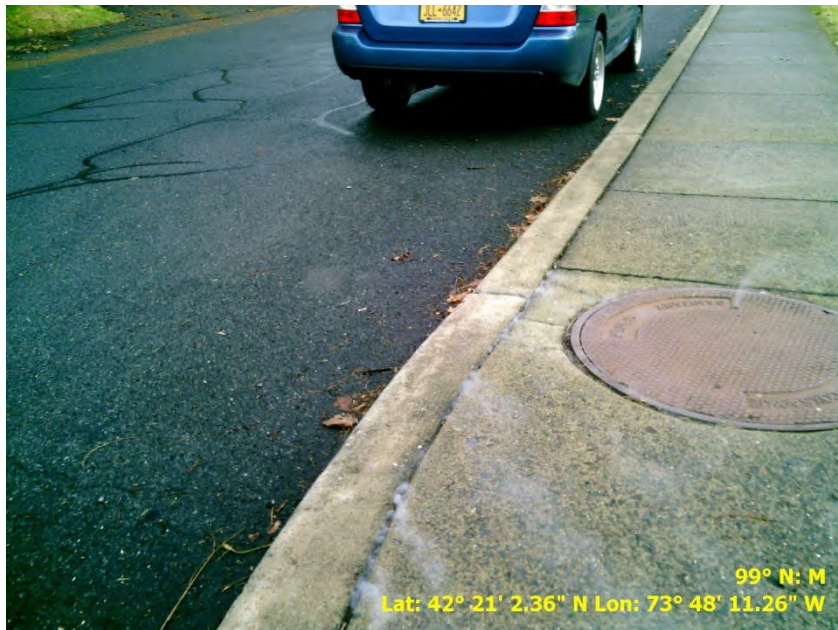
Smoke from the area surrounding a manhole indicates a broken sewer line and/or cracks in the manhole cover, casting or underground structure.

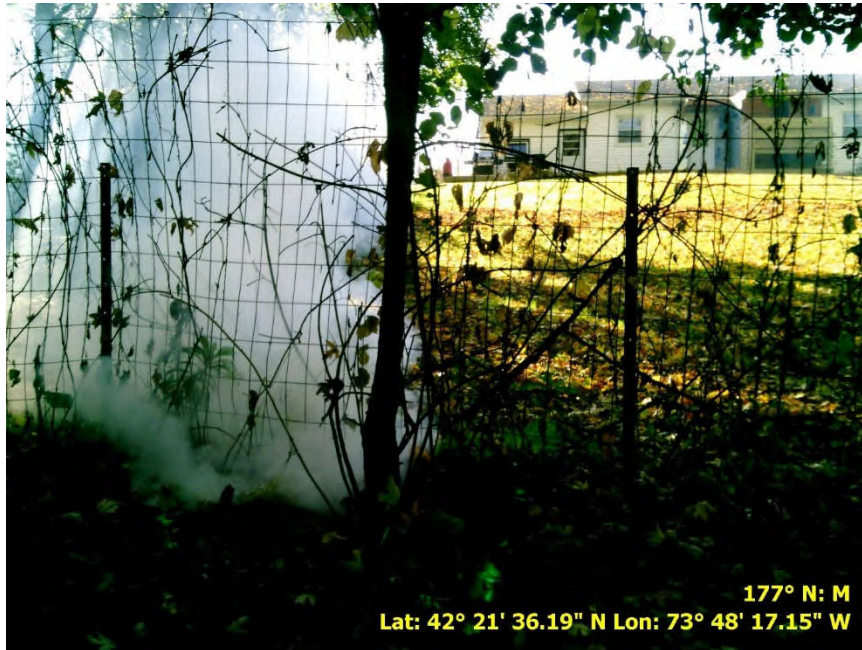
### Ground/Sewer Connection Laterals

Smoke from the ground indicates a break in the sewer lateral connecting a building to the sewer collection system. Breaks allow water into the sewer collection system during rain events.

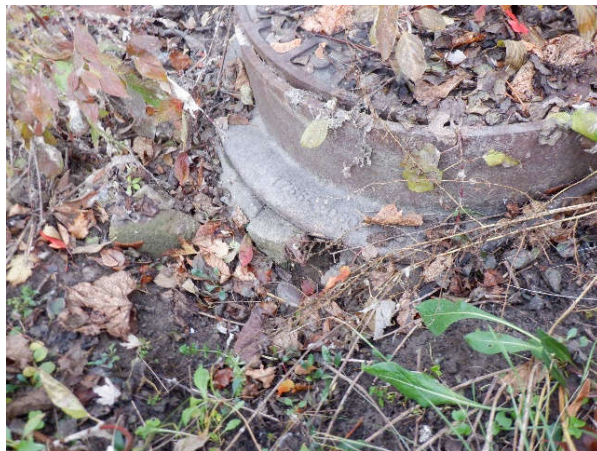
MH 10-20 west of WCPS, hole

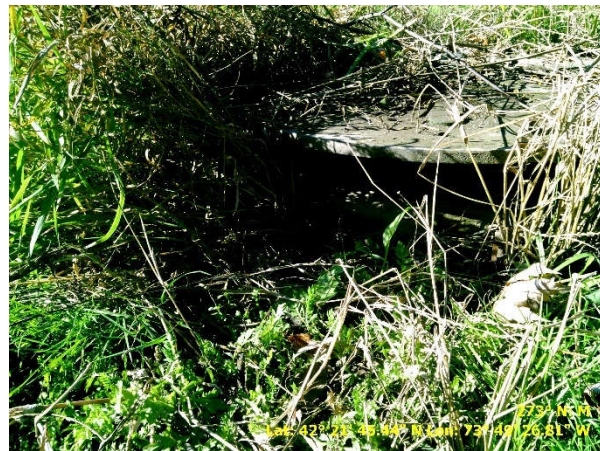
MH 10-10 west of WCPS, bad condition

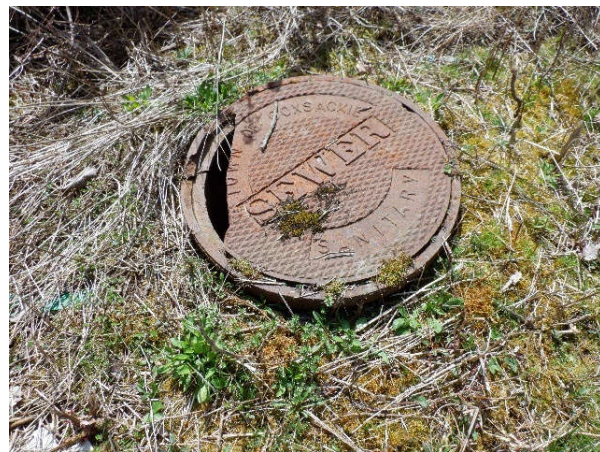
Vermylea Tributary 12-60

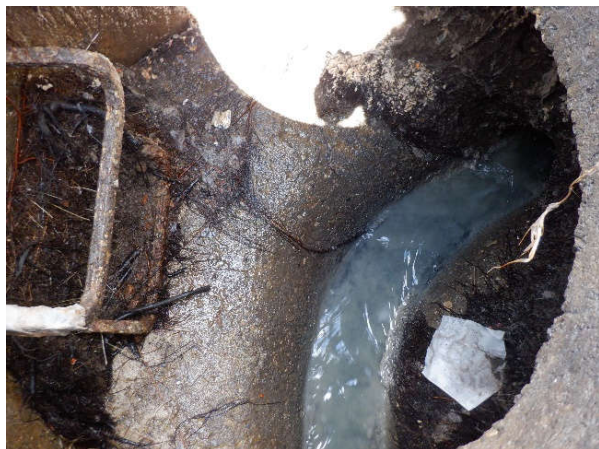
Cocksackie Creek MH 11-80 infiltration signs

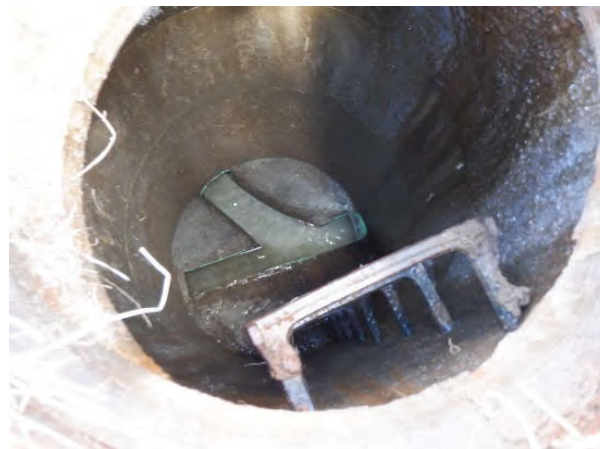
Vermylea 12-90 signs of infiltration

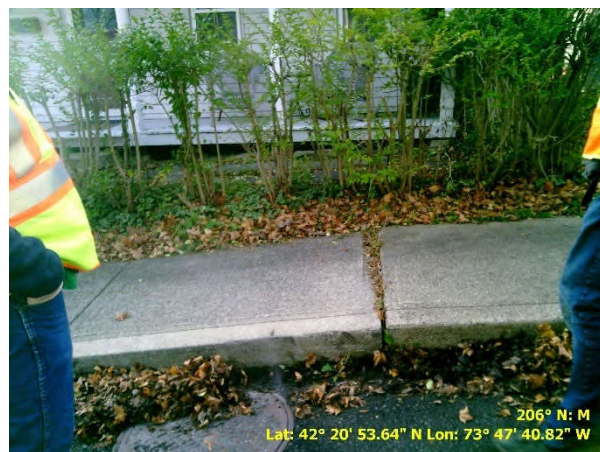
Church E MH3 smoking at edges

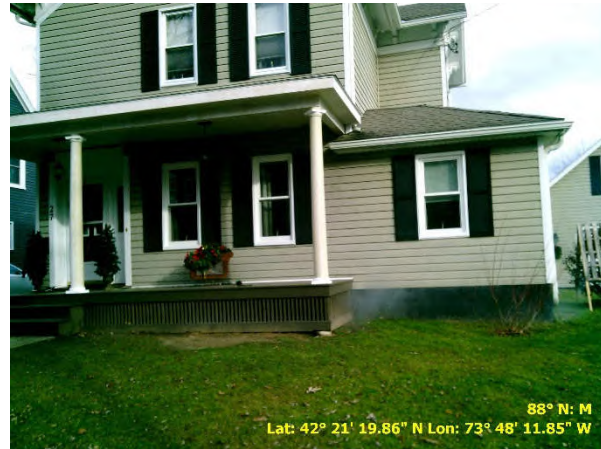
27 Elm – smoke under porch

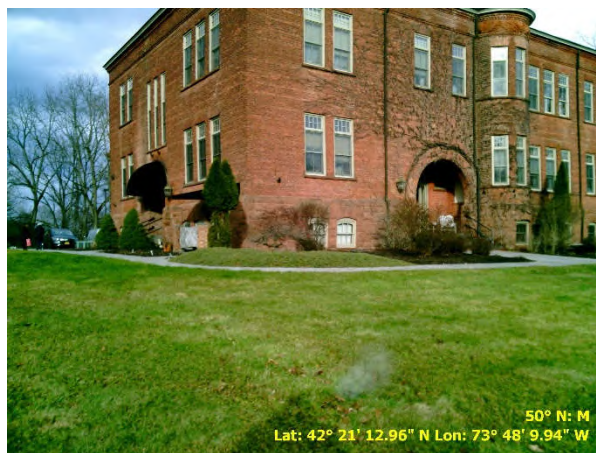
91 Mansion – clean out cap defective

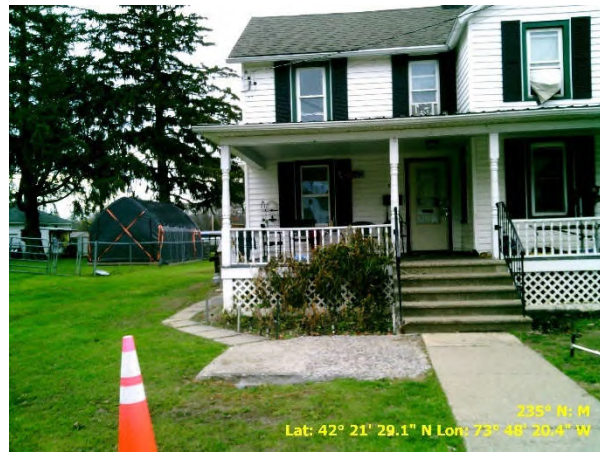
56 Lafayette - lateral

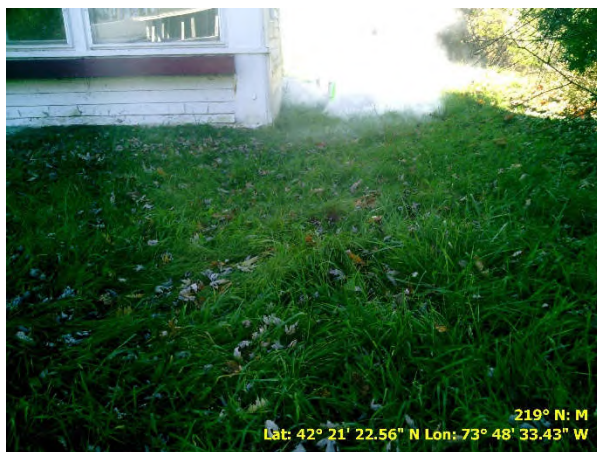
126? Mansion – clean out cap defective

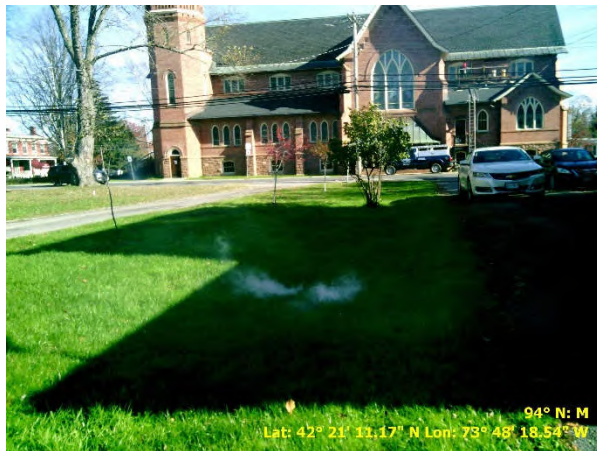
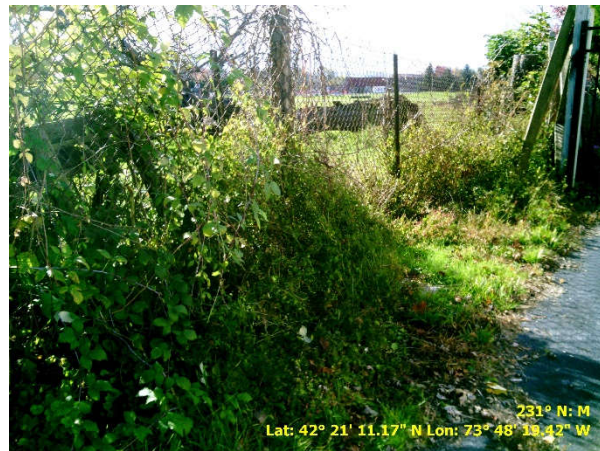
7 Washington – apparent drainage pipe, lawn and area next to drive smoked

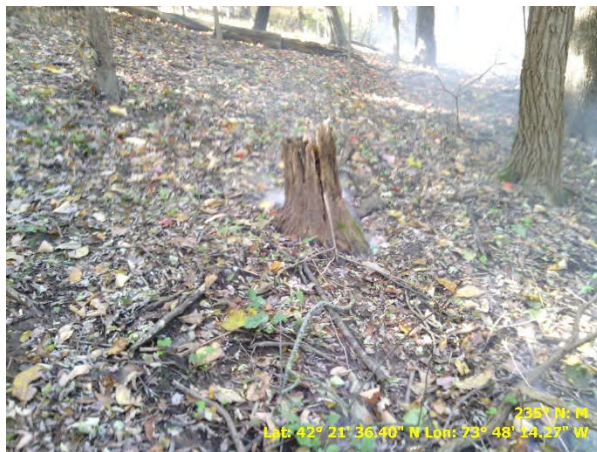
Near VDW2 – broken lateral from Wayne?

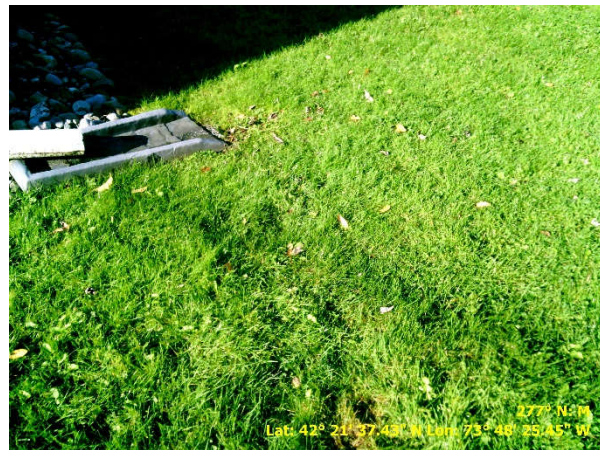
31 Van Dyke – lateral? Lawn smoked

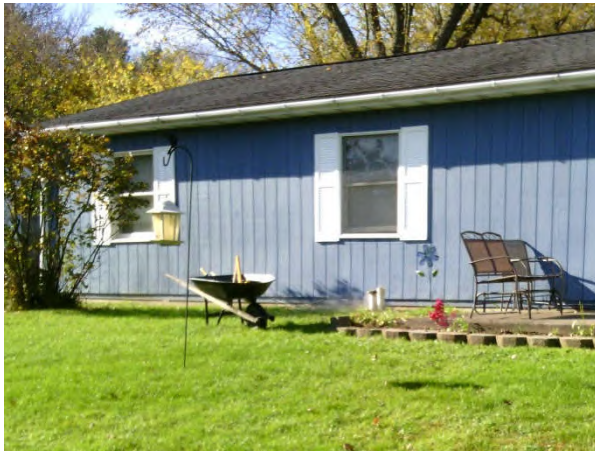
16 Wayne – clean out cap defective

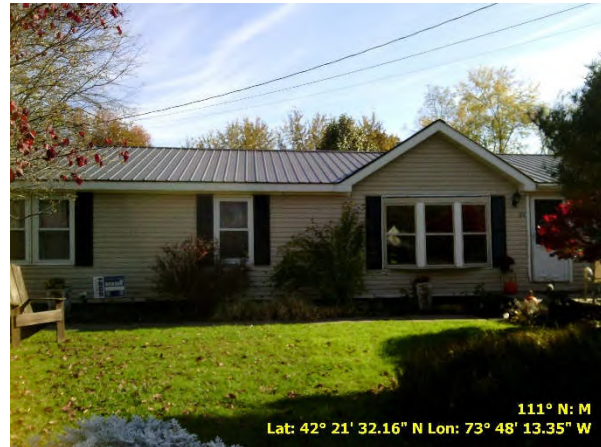
21 Wayne – roof lead or clean out

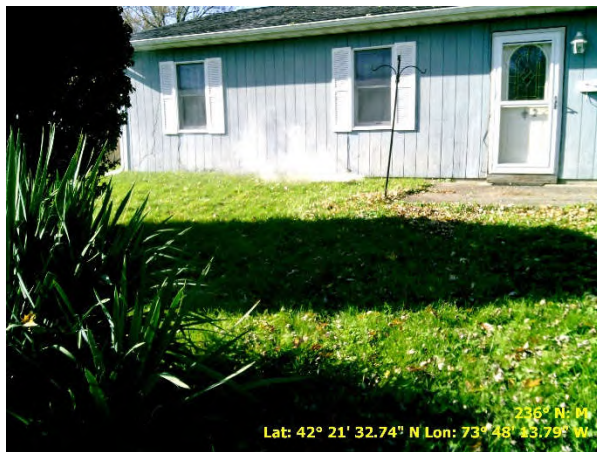
22 Wayne – clean out cap defective

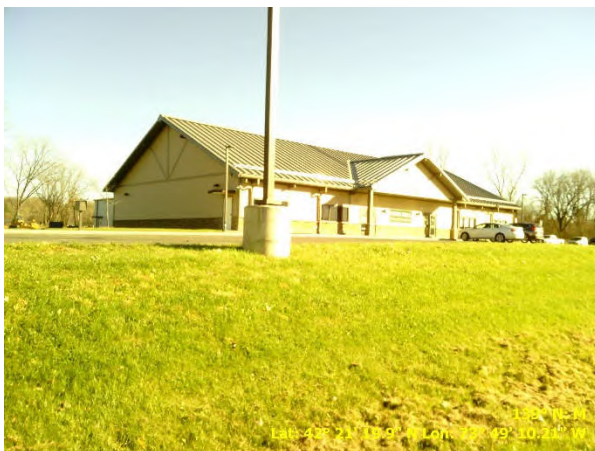
## 56 Bailey – smoke in building, floor drains

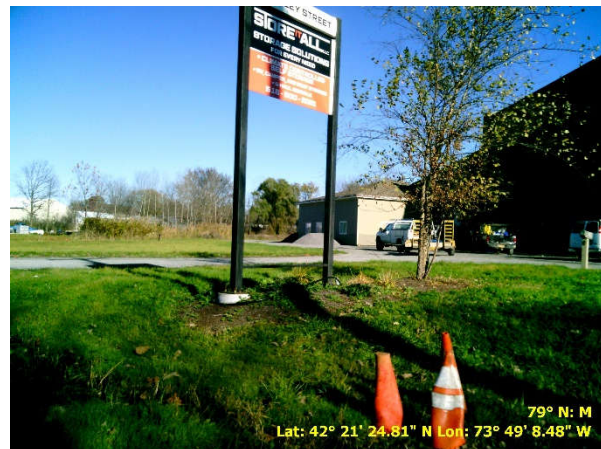
40 Bailey – broken lateral in ditch

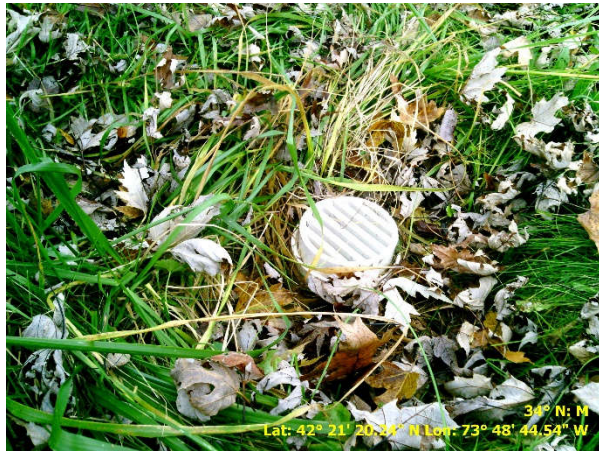
33 Spencer – clean out smoked

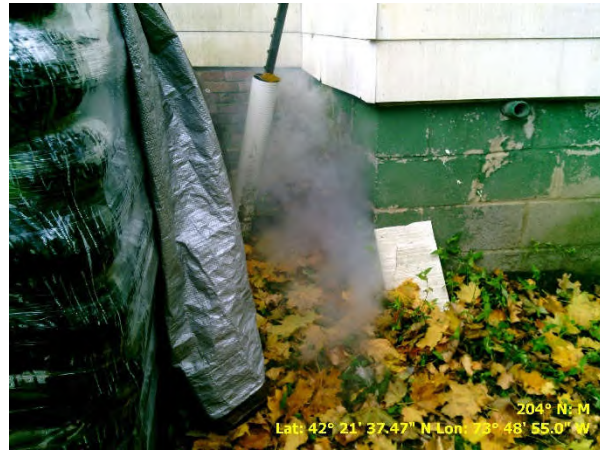
4 Lawrence – broken lateral?

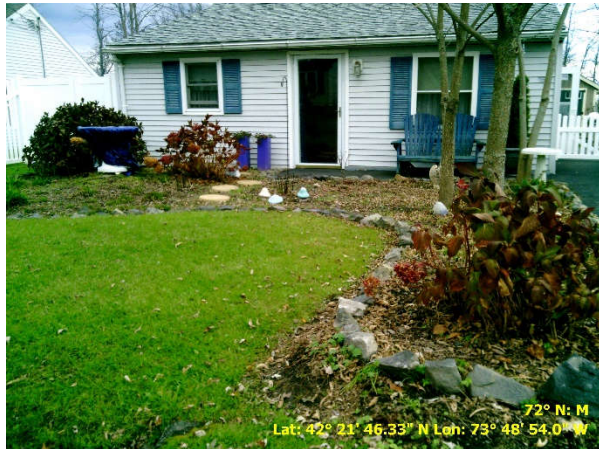
39 Lawrence – smoke in house

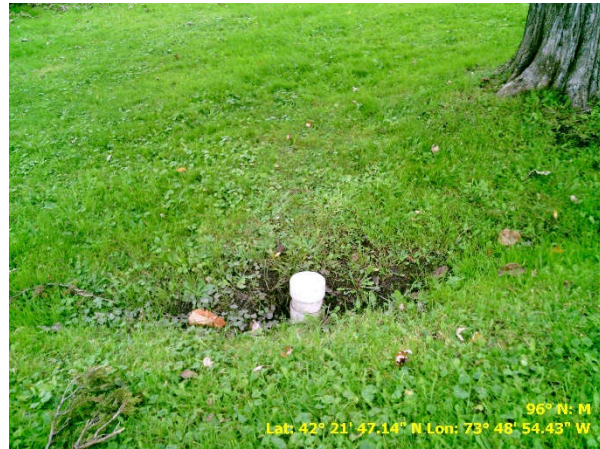
41 Lawrence – clean out defective

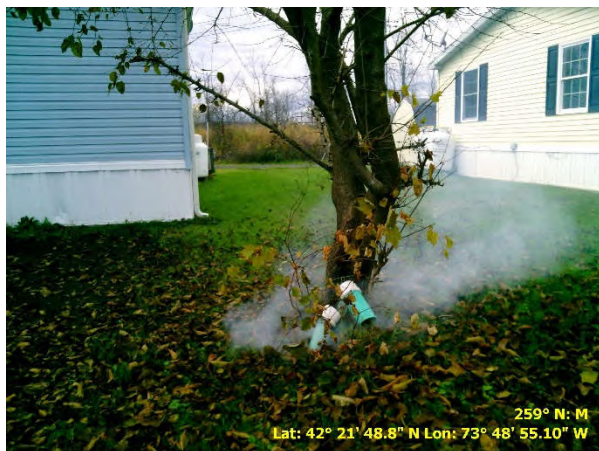
44 & 46 Lawrence – clean outs defective

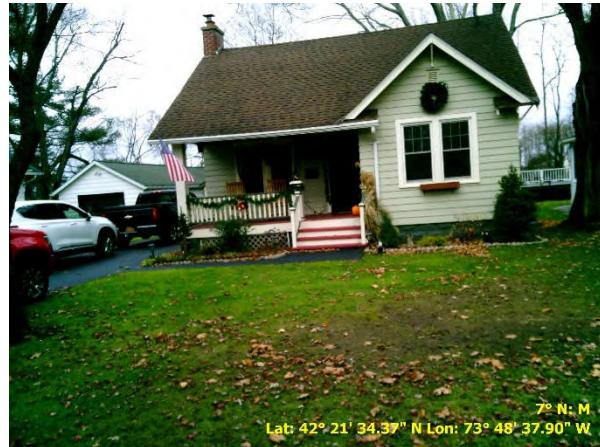
61 Van Dyck – smoke in house

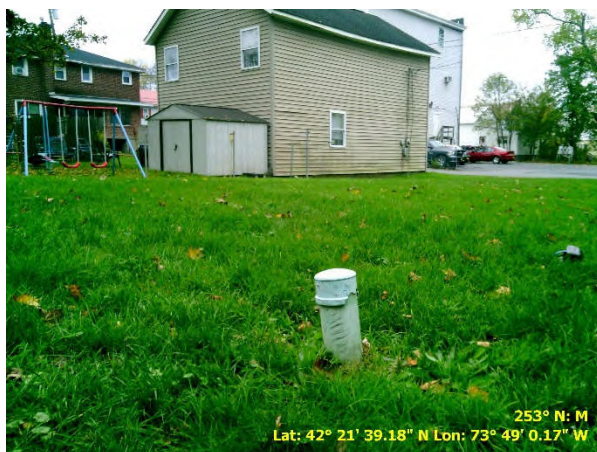
7 Whitbeck – clean out defective

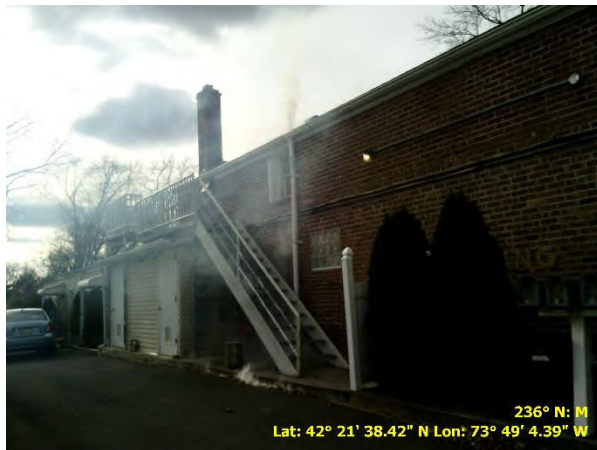
228 Mansion – lateral

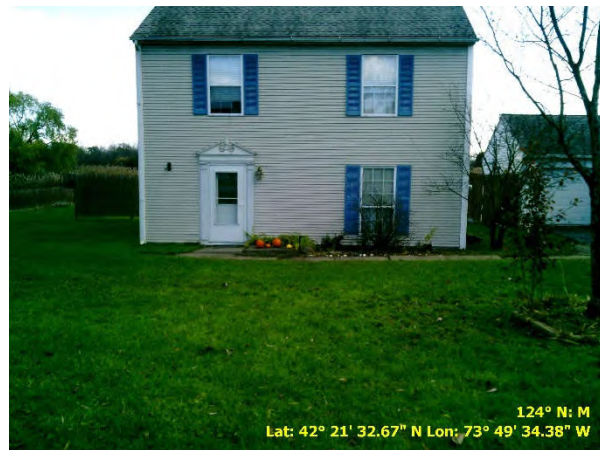
19 Matthew – clean out defective

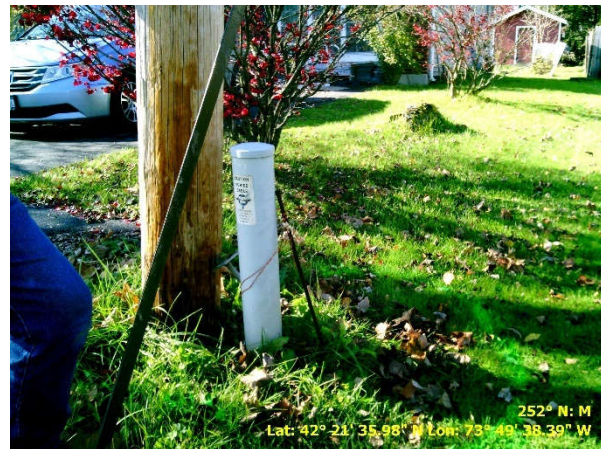
18 Apple Blossom – lateral at utility

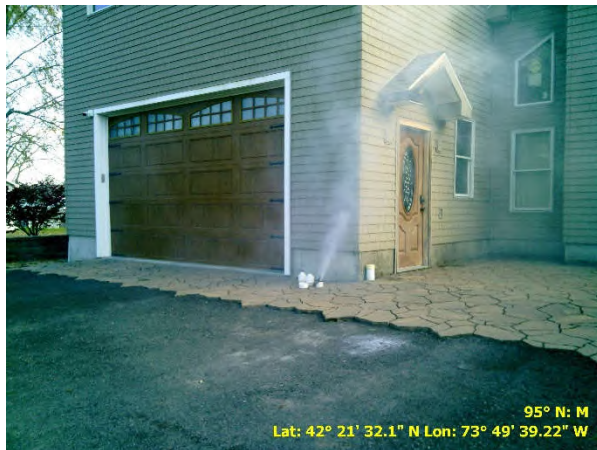
23 Apple Blossom – clean out cap missing

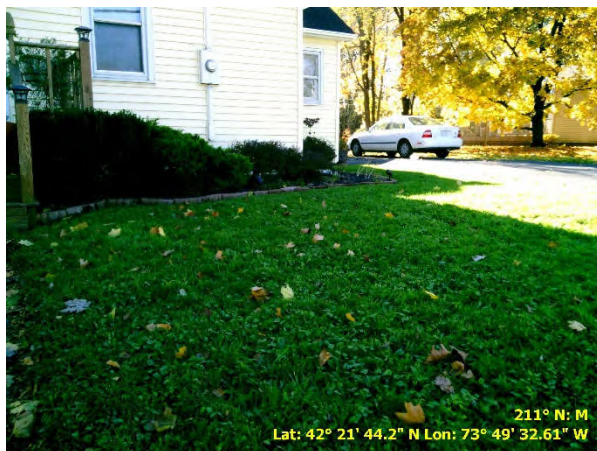
314 Mansion – basement vent smoked

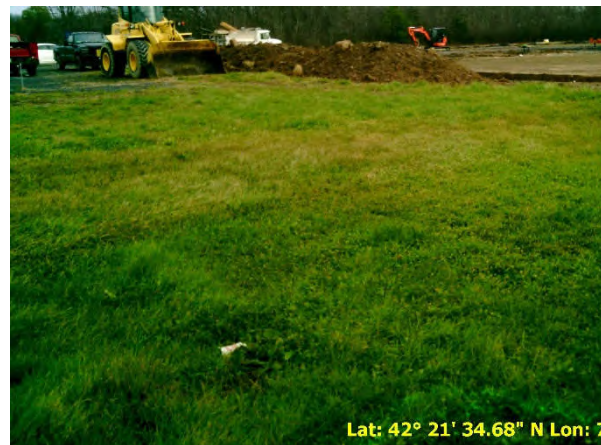
11776? 9W – clean out cap missing

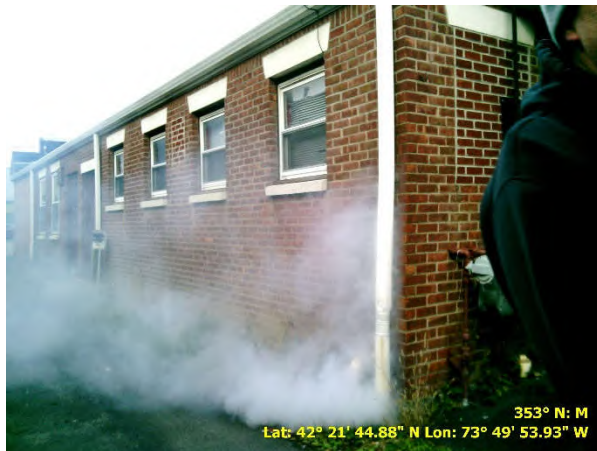
WC Plaza Hall of Ravens – roof lead and vent

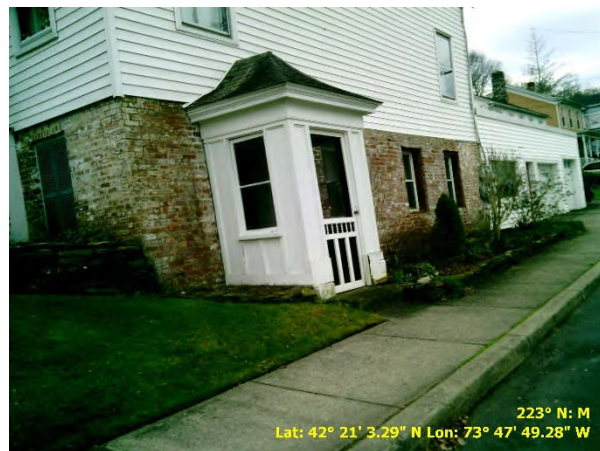
17 Ely – broken lateral? Ground smoked

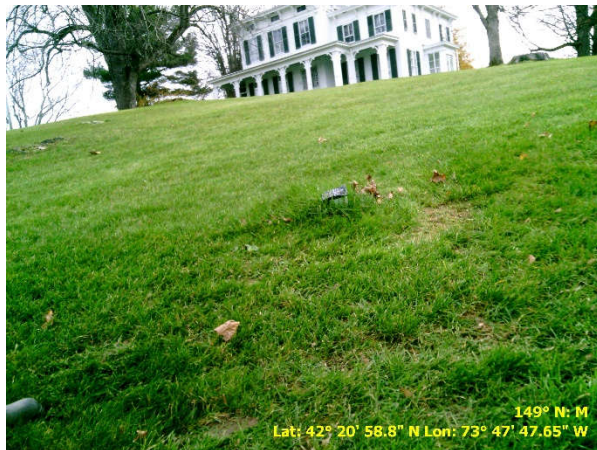
40 Ely – broken cleanout or lateral

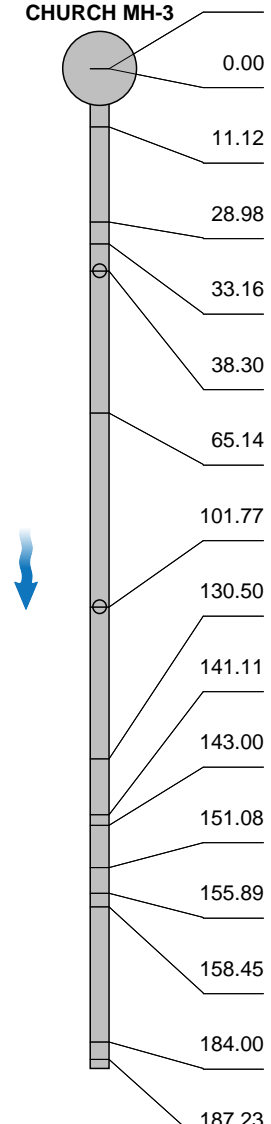
1:1427	Distance	Code	Observation	Counter	Photo	Grade
	0.00	AMH	Manhole, CHURCH MH-3 / CHURCH MH-3	00:00:07

11.12	CM	Crack Multiple, from 12 o'clock to 12 o'clock	00:00:31		
	28.98	DSC	Deposits Settled Compacted, 5% of cross sectional area, at 2 o'clock	00:01:04

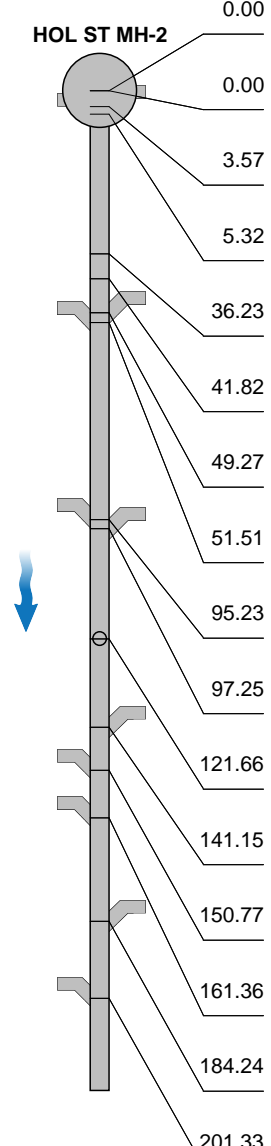
3.57	TFC	Tap Factory Made Capped, at 9 o'clock , 6 inch dim	00:00:43		
	5.32	TFC	Tap Factory Made Capped, at 3 o'clock , 6 inch dim	00:01:01		
	36.23	DSC	Deposits Settled Compacted, 5% of cross sectional area, from 7 o'clock to 12 o'clock	00:01:56
