# ENGINEERING REPORT

## EPG #105268

VILLAGE OF COXSACKIE  
NY0033545

## COLLECTION SYSTEM PLAN

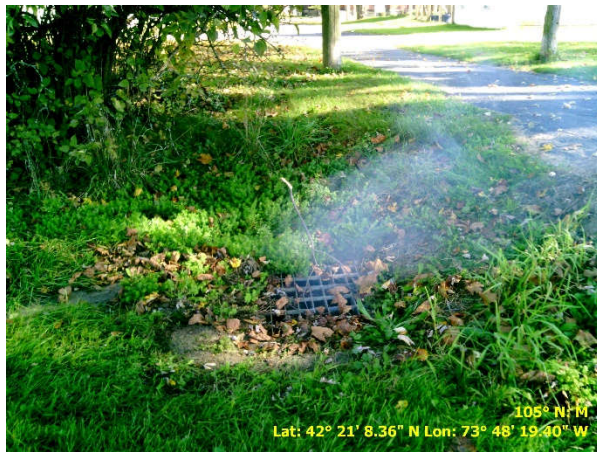
School Pass edge of walkway

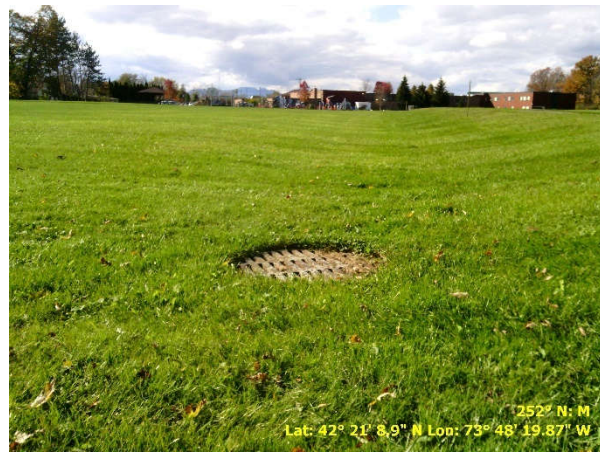
West of School Pass walkway at field

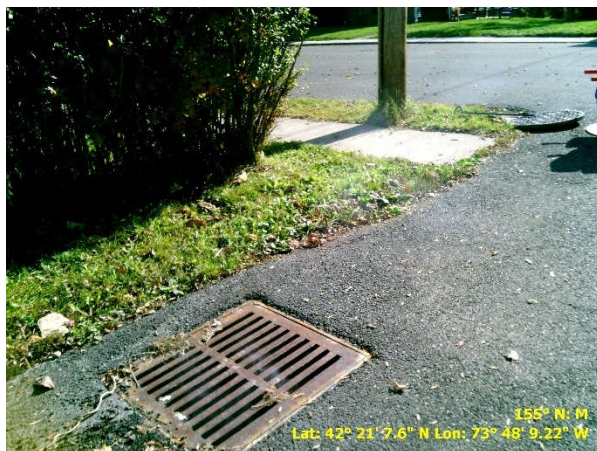
Hillcrest near corner with Freleigh

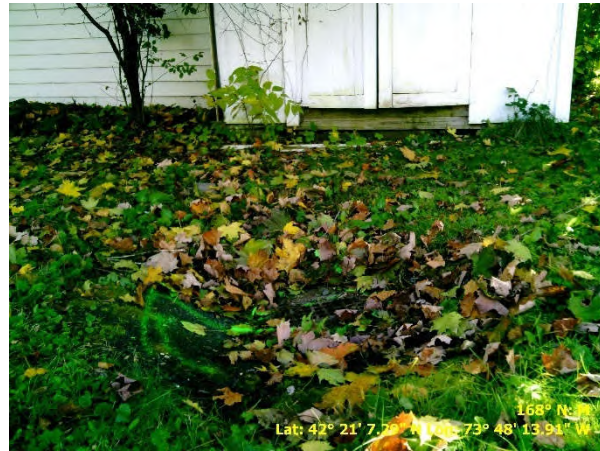
22 Washington CB behind residential shed

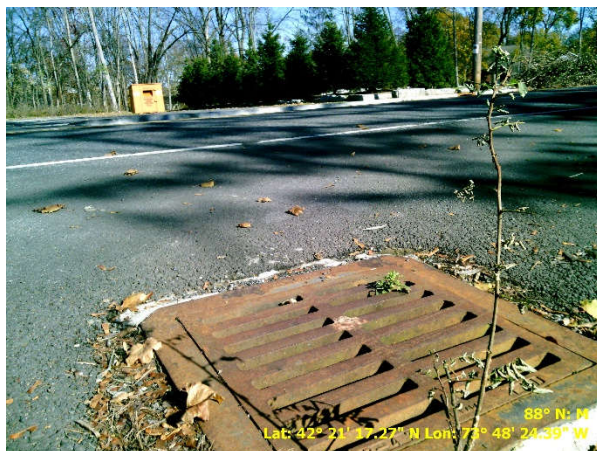
104 Mansion CB across from Sunoco Station

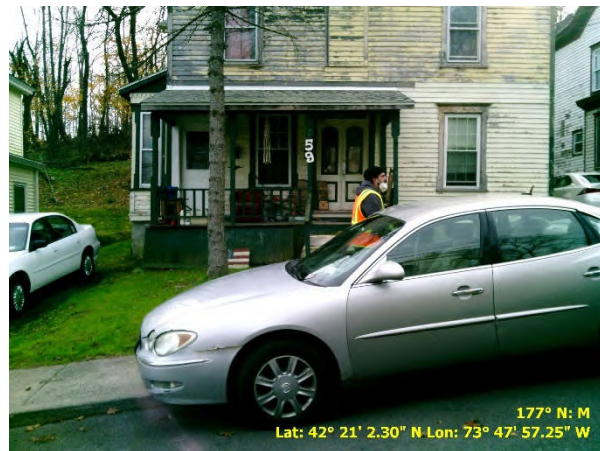
59 New Street CB

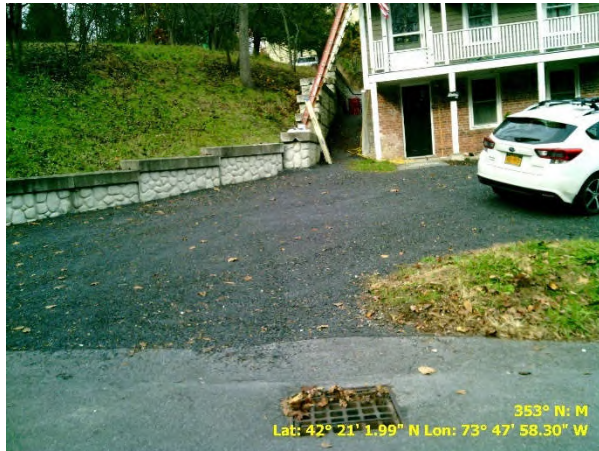
60 New Street CB

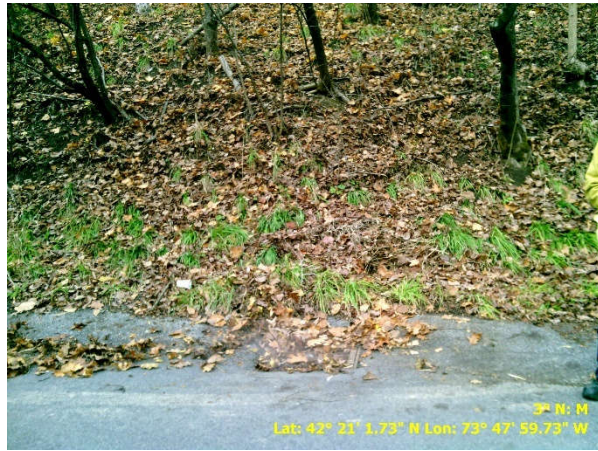
64 New Street CB

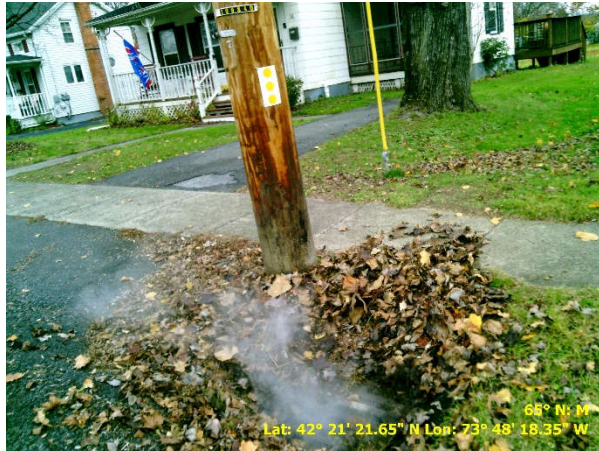
31 Lafayette CB

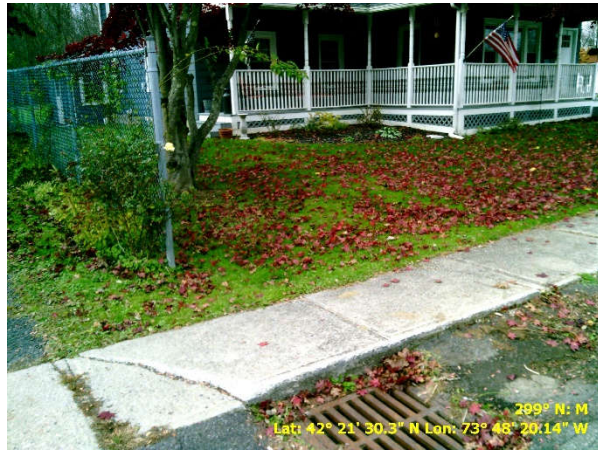
64 Lafayette CB

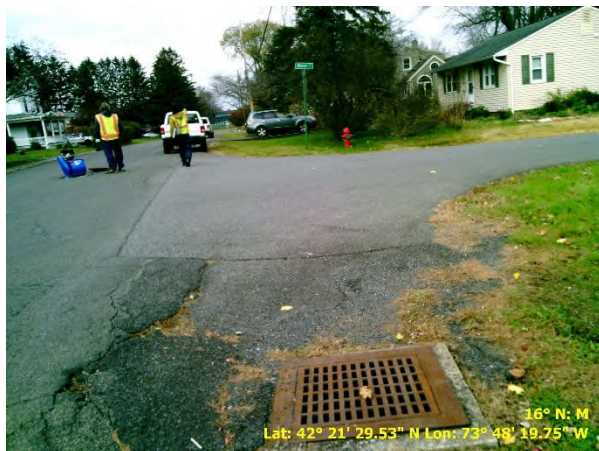
Lafayette SE corner with Wayne CB

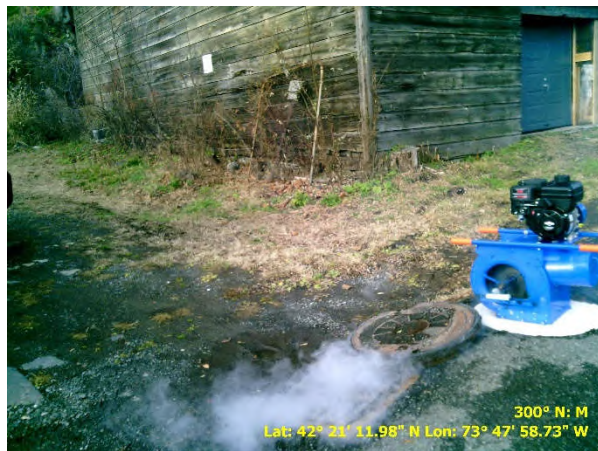
CB Riverside Ave adjacent to MH RA 12

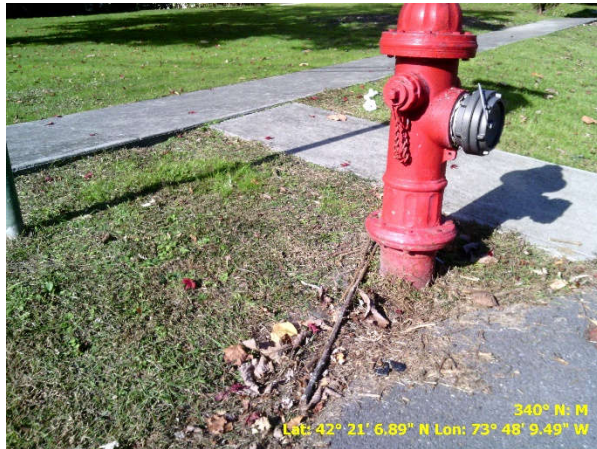
Hillcrest ground smoked next to hydrant

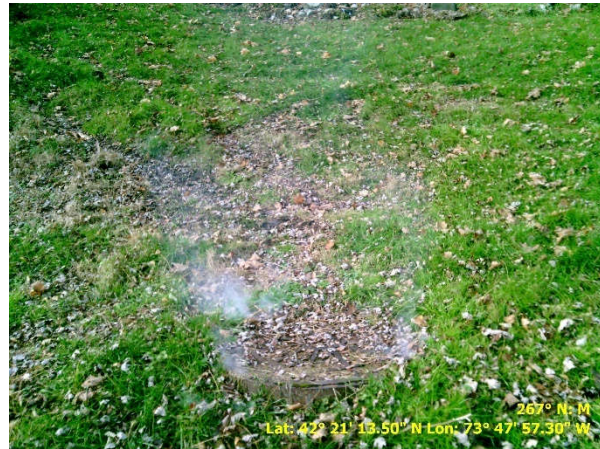
MH behind 7 Riverside (how connected?)

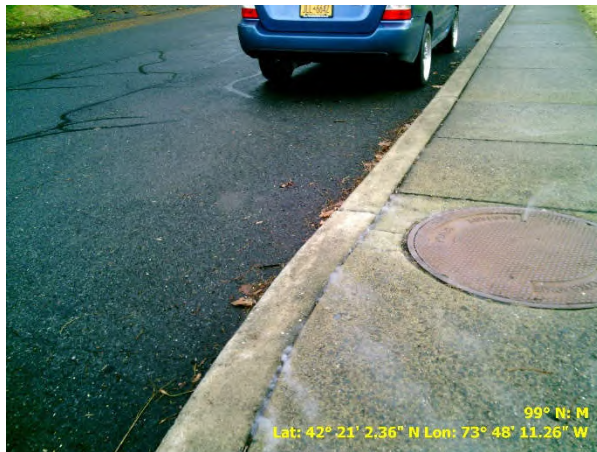
New Street curb next to MH4 smoked

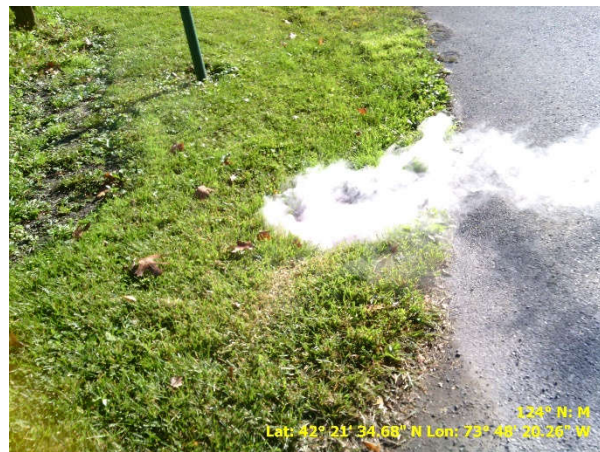
CB; NE side Lafayette corner with Wayne

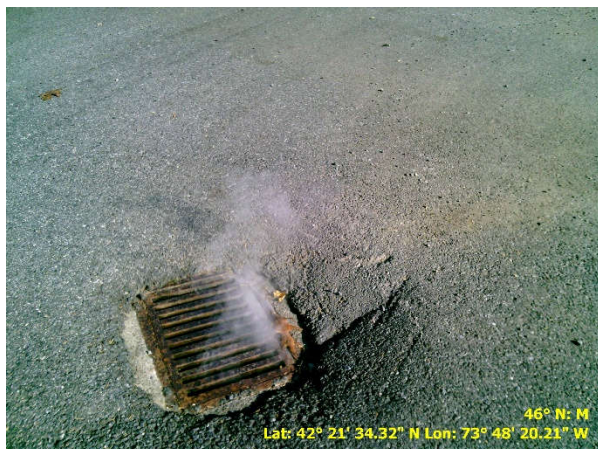
CB intersection Lafayette and Wayne

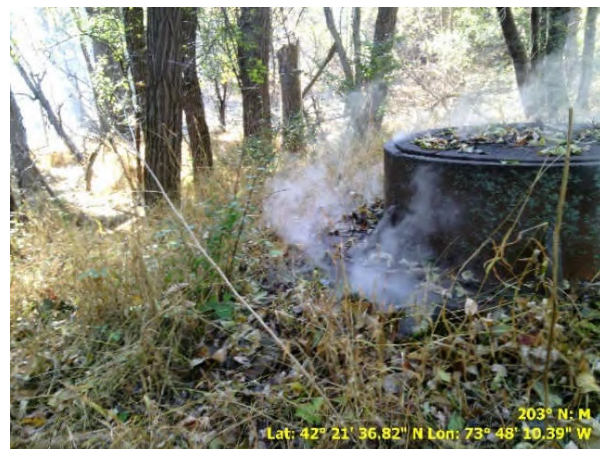
Van Dyck Woods easement MH VW3

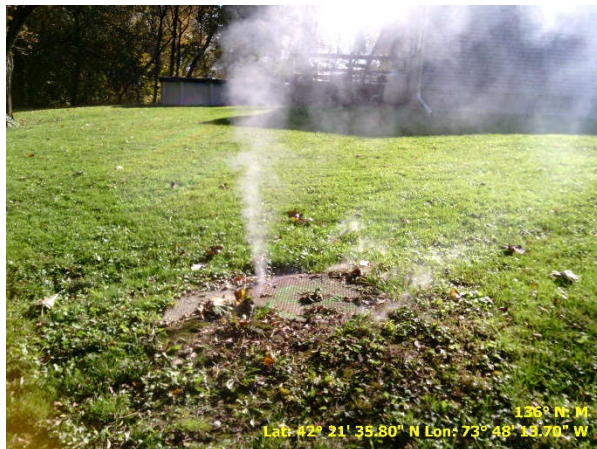
WD10 at 29 Wayne, ground smoked

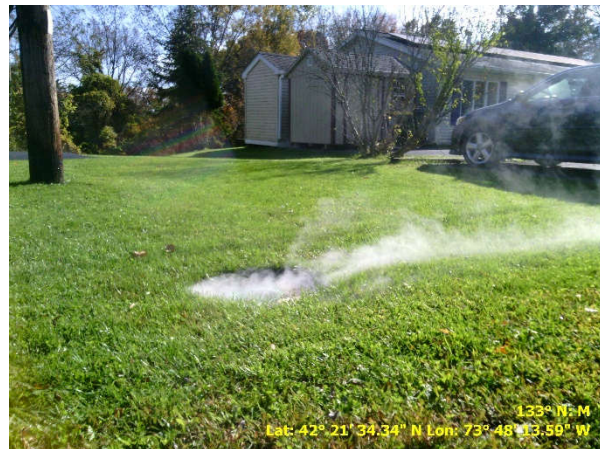
WD4 at 25 Wayne, ground surrounding smoked

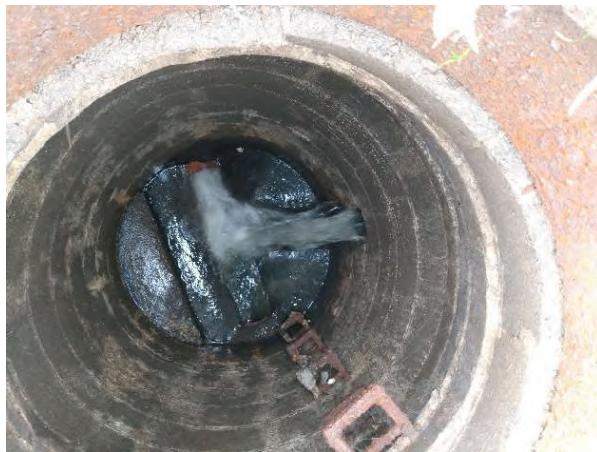
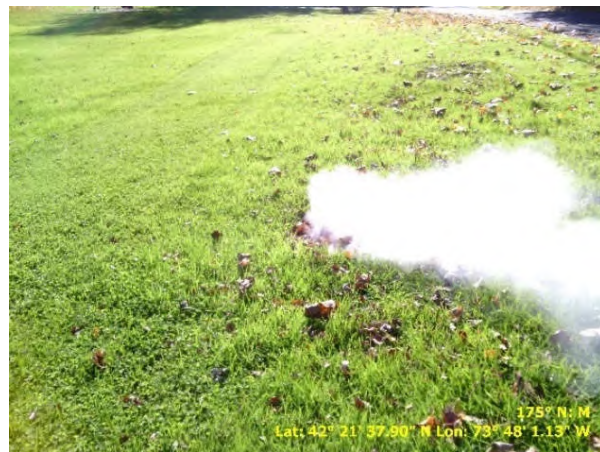
Riverside MH RA-4, receives flow from Van Dyck Woods easement (inside photo after rain)

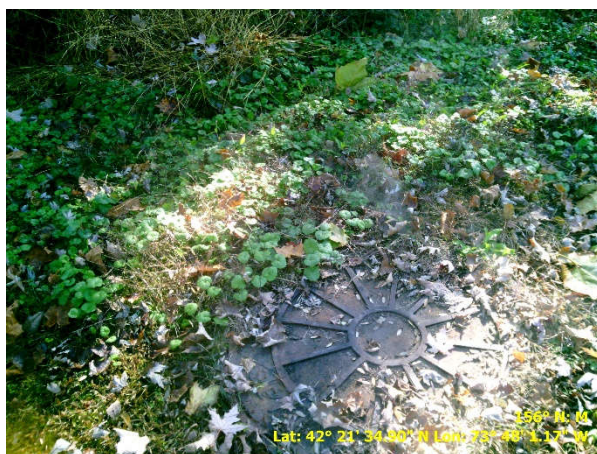
Riverside RA6, smoking around edges

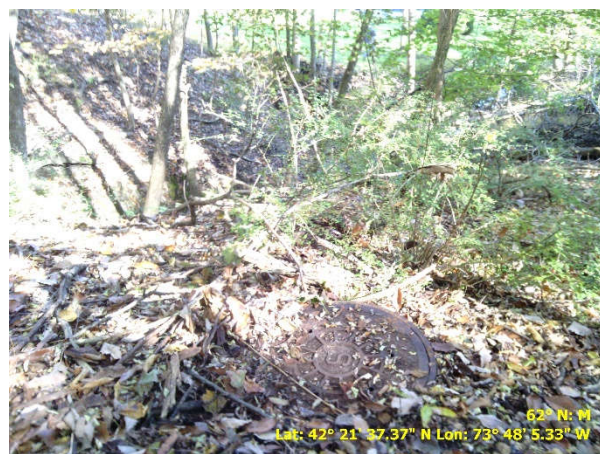
Van Dyck Easement 5, edges and ground smoked

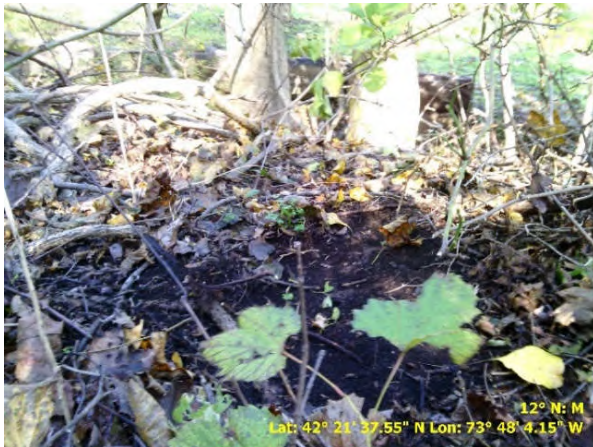
MH no ID located across stream from VDW 6

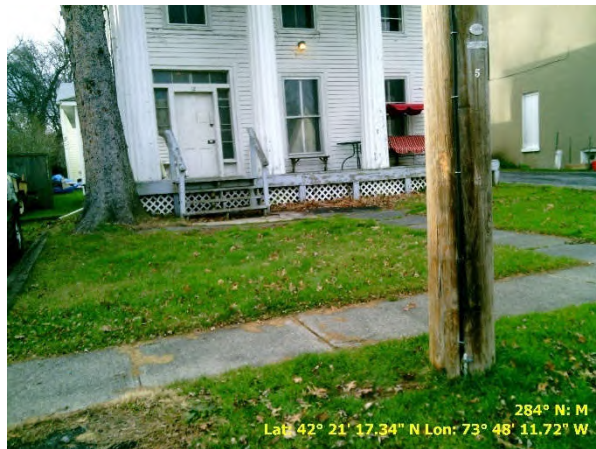
12 Elm – pole at lateral

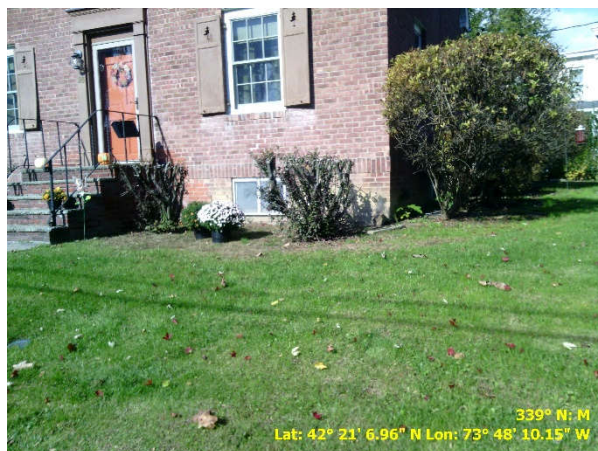
16 Freleigh – roof lead

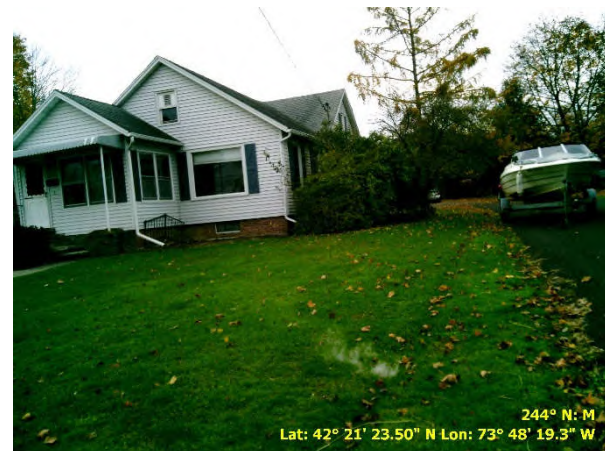
34 Lafayette - lateral

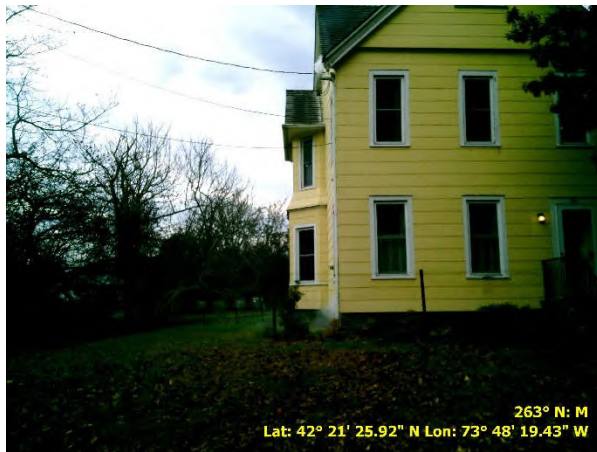
46 Lafayette – roof lead

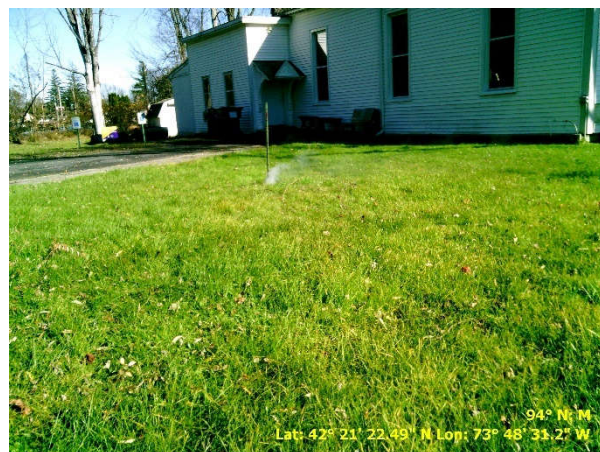
123 Mansion – lateral and catch basin

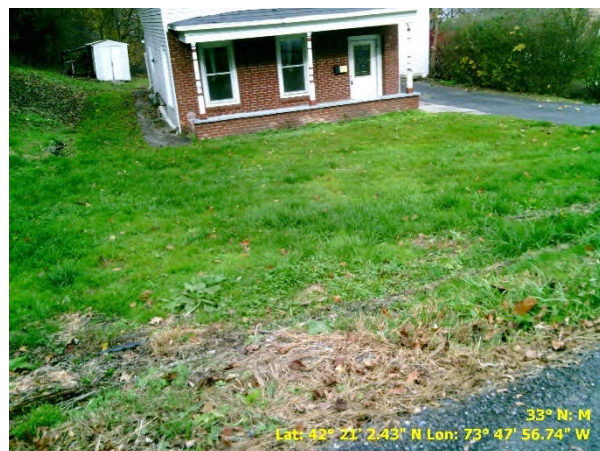
56 New – ground smoke (lateral?)

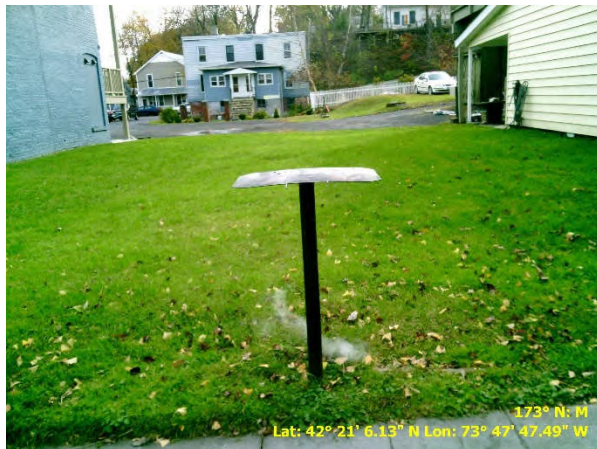
32 Reed – abandoned lateral? Vacant lot

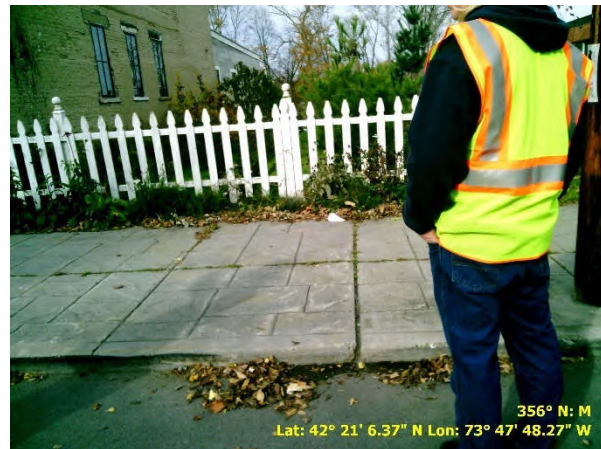
35 Reed – abandoned lateral? Vacant

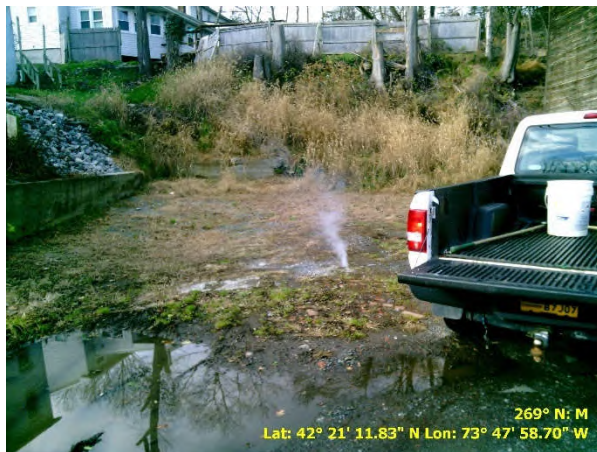
Riverside (behind 65 Mansion)-lateral

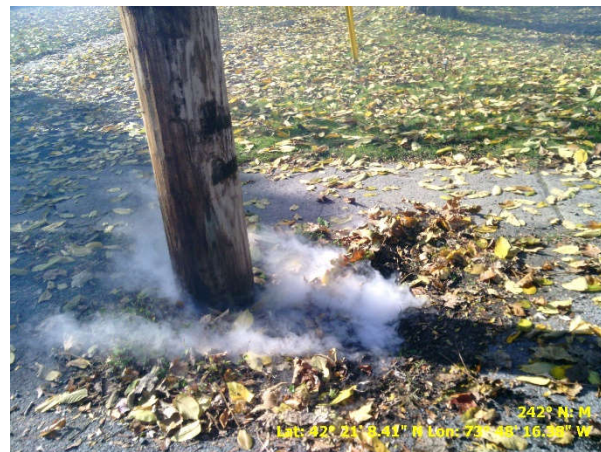
19 Washington – utility pole at lateral?

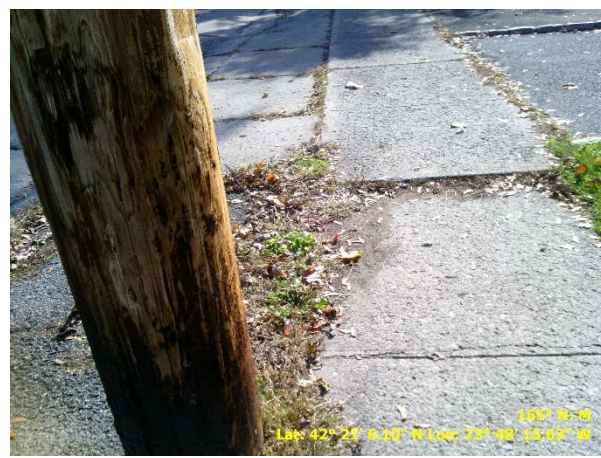
29 Washington – utility pole at lateral?

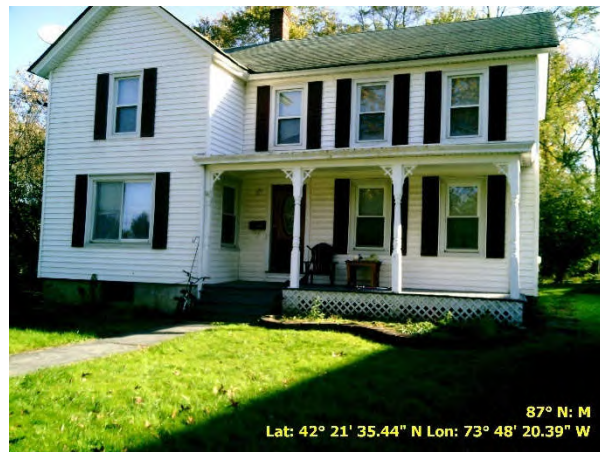
93 Lafayette – smoke from roof drain

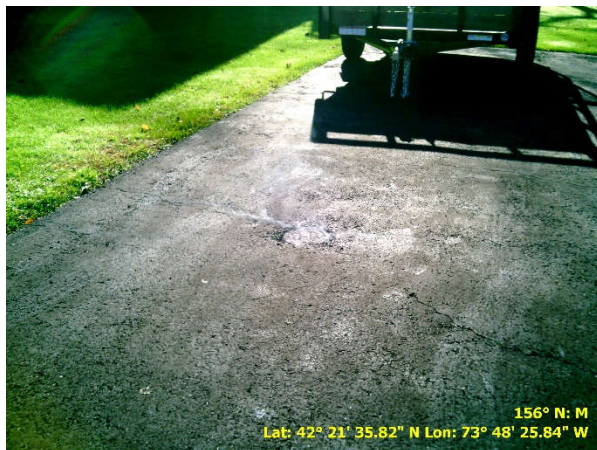
32 Van Dyck – driveway smoked, lateral?

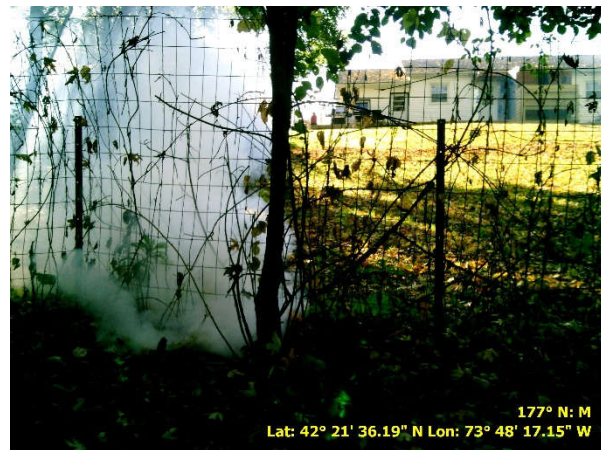
35 Wayne – back yard, lateral

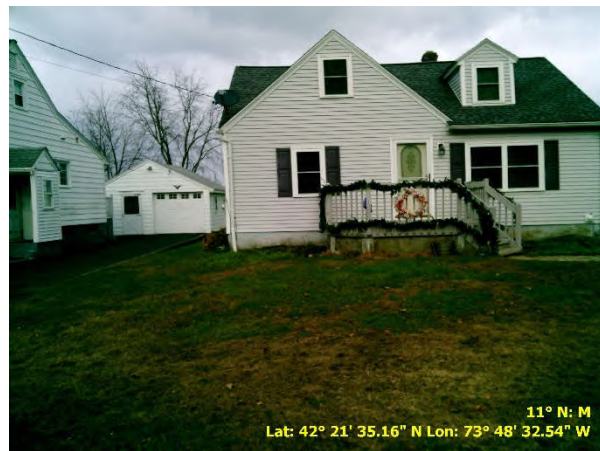
47 Van Dyck – roof lead

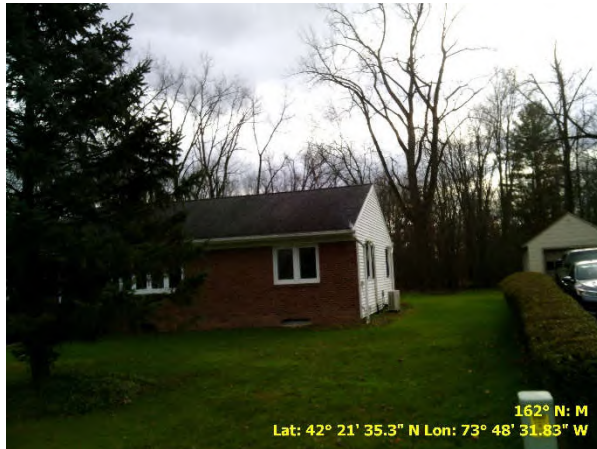
48 Van Dyck – roof lead

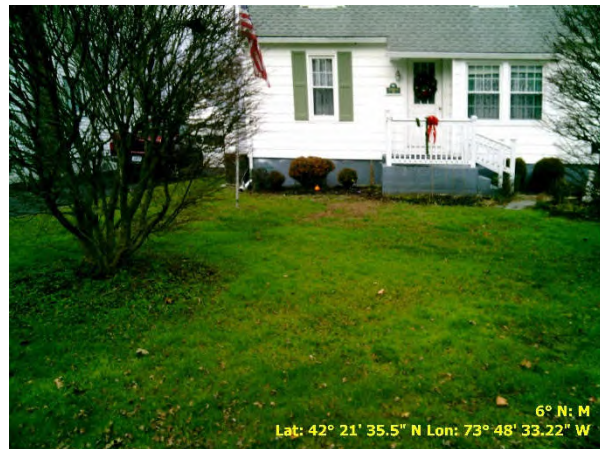
49 Van Dyck – roof lead

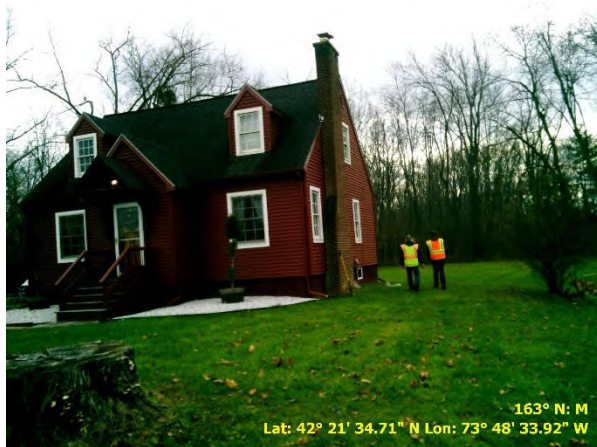
52 Van Dyck – roof lead

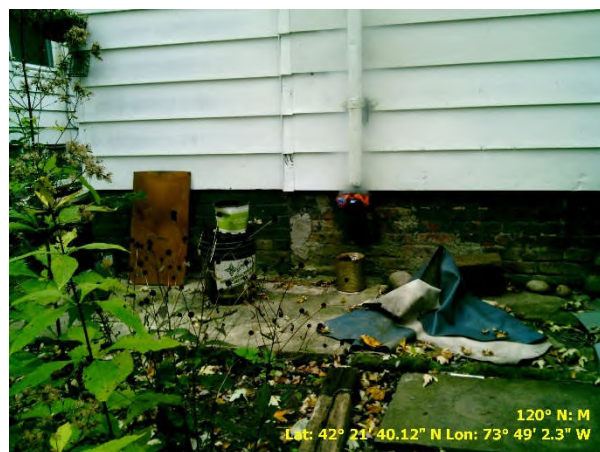
8 Whitbeck – Roof lead, basement sump

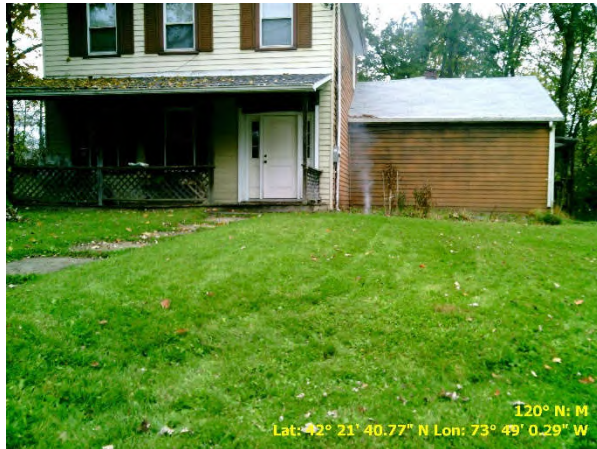
11 Whitbeck – lateral or clean out

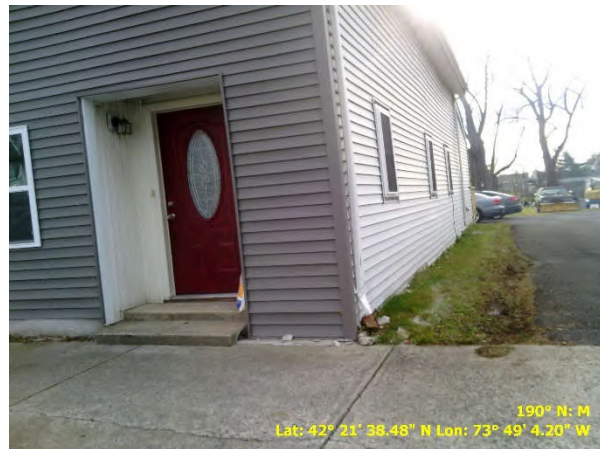
226 Mansion - lateral

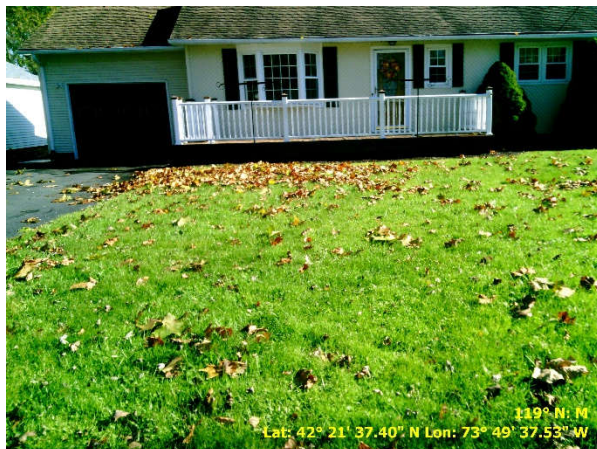
11 Apple Blossom – lateral, smoke at porch

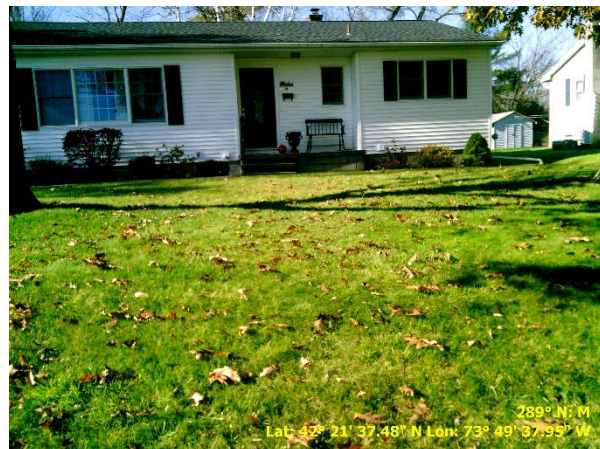
14 Apple Blossom – lateral, smoke at porch

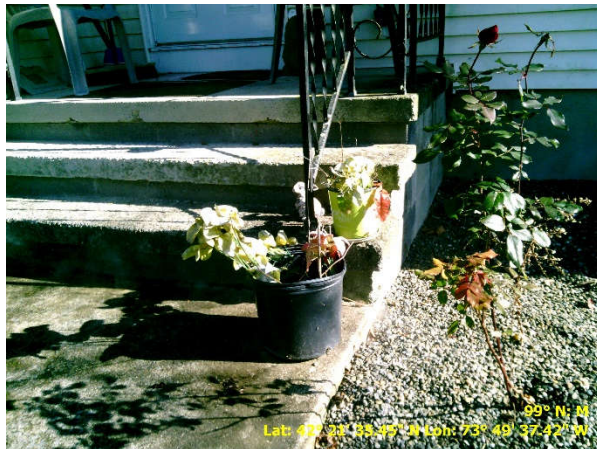
15 Apple Blossom – lateral, smoke at porch

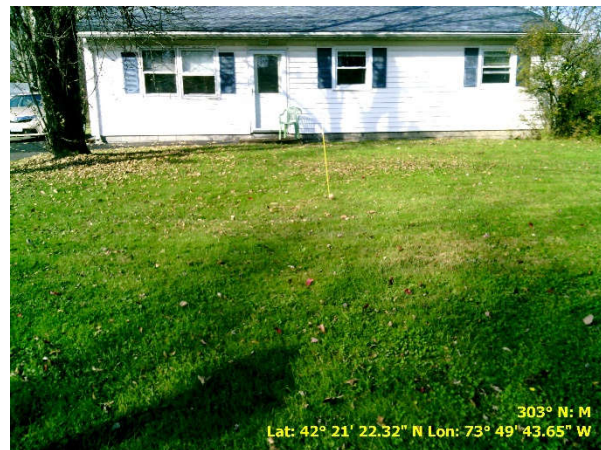
10 Howard – smoke in house

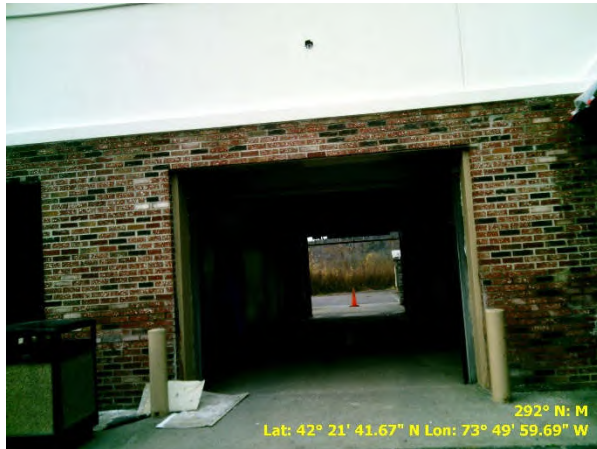
Hope Plaza - Car wash bay smoked

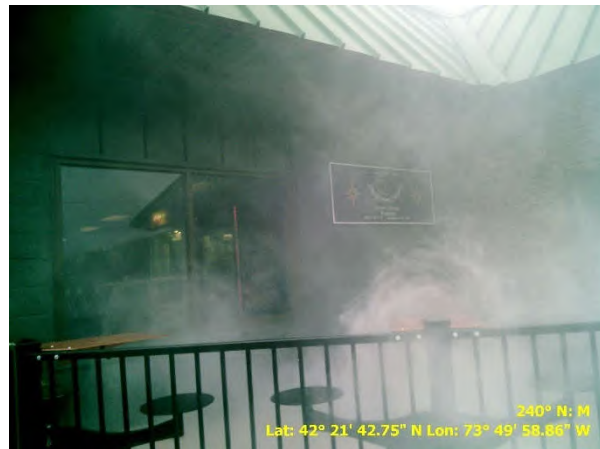
Greater Things – lateral, smoke at deck

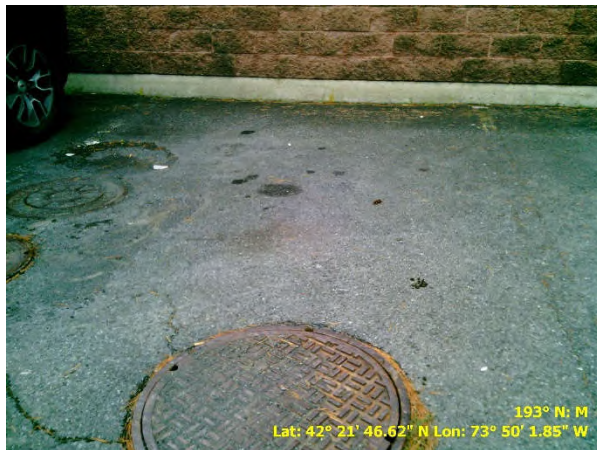
Hope Plaza – Tops smoke at MH

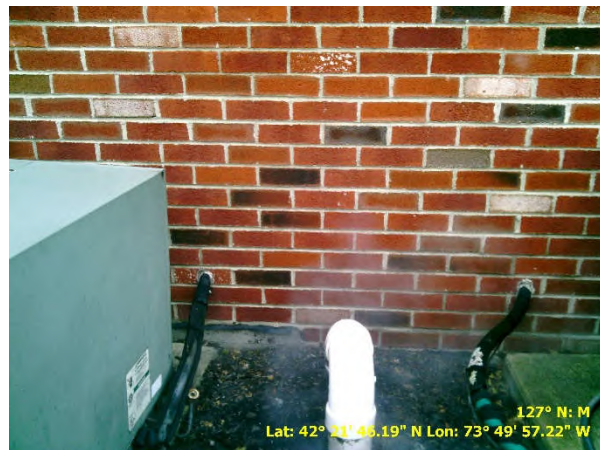
Urgent Care building vents

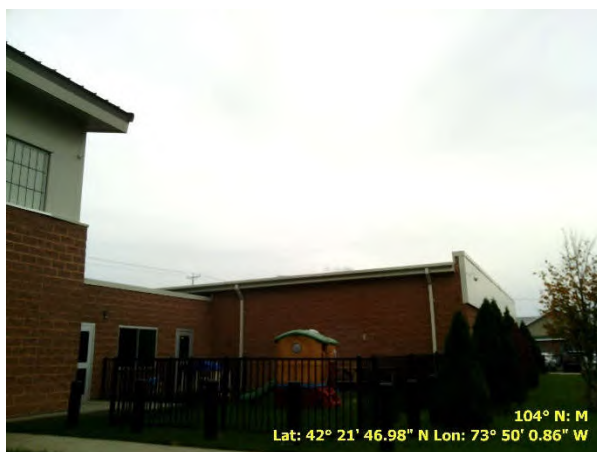
Hope Plaza YMCA – smoke in building

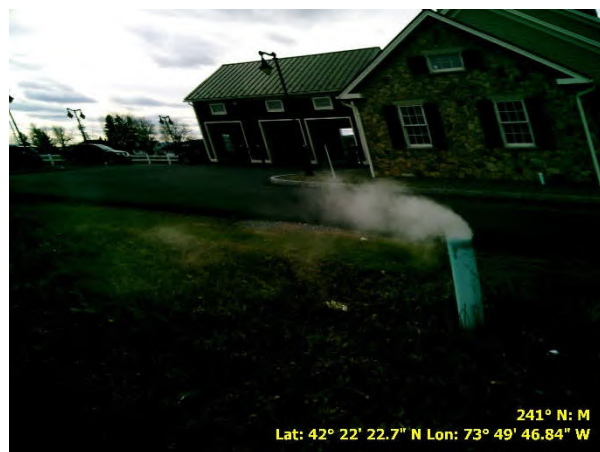
Rte 9W Bank – clean out or vent?

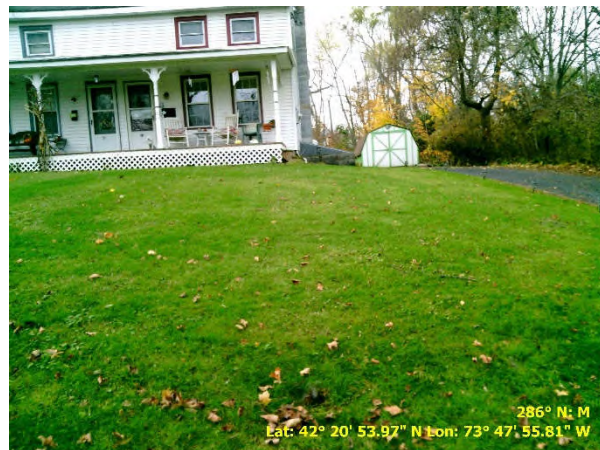
19 Hollister – lateral? Lawn smoked

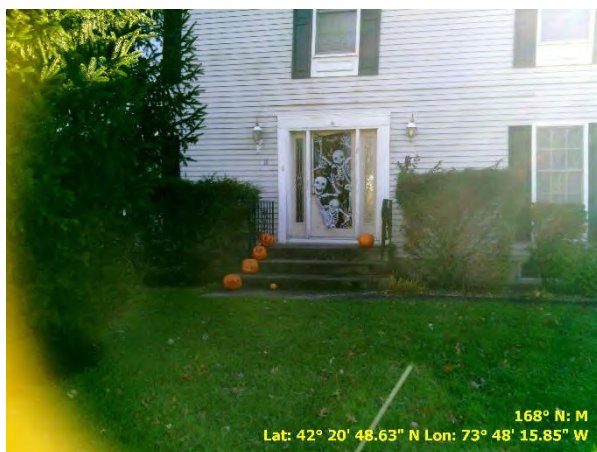
18 Molly White – roof lead and/or lateral

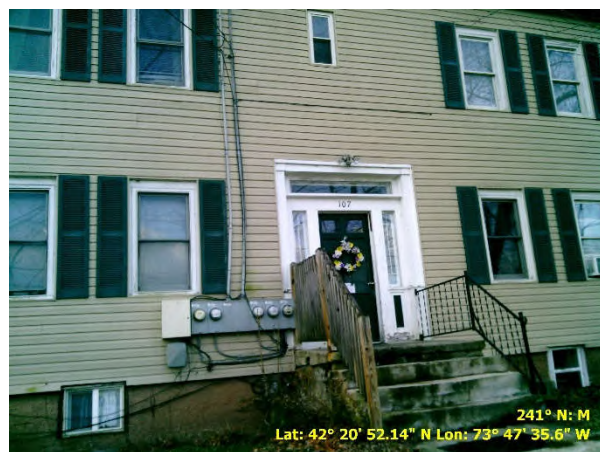
107 South River – basement vent smoked
